Experimental Study on Shear Strengthening of Reinforced Concrete Beams Using Different Techniques of Concrete Jacketing

Abstract

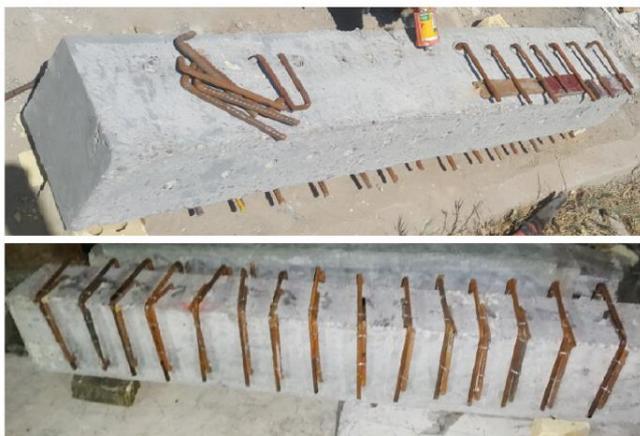
Fig. 4 Details of the beam (S.-J. + Stirrup).

As shown in Fig. 4, the dimensions of the concrete jacket were the same as the previous one. The difference between the strategy used to strengthen this beam and the previous one is in the details of the concrete mixture and the addition of stirrups instead of using steel fiber. The concrete jacket was cast by Self Compacted Concrete (SCC) after adding stirrups. Details of the added shear reinforcement in the concrete jacket are shown in Fig. 4. The mixture proportion and the mechanical properties of the hardened (SCC) mixture are presented in Tables 8 and 9, respectively. The mix design used in (SCC) is the same as (SCFRC) that used in the beam (S.-J. + Stirrup) with the difference of cancellation the steel fiber, which led to a decrease in the proportion of water and plasticizers necessary to obtain fresh mixture within the self-compacted concrete requirements.

When the beam (Jac. + Stirrup) reached 28 days' age, the following steps were taken to strengthen it. The first step was to prepare the concrete substrate by grinding its face using a rotary diamond grinder. Then holes of 8 cm deep and 12 mm diameters were made by an electric drill. The holes were made on the concrete surface in the locations specified to add anchors. Steel reinforcement of 10 mm diameters (D10) with angle shape was used as a shear connector. The details and the dimensions of the anchors are presented in Fig. 4. The beam surfaces and the drill holes were cleaned using compressed air. Then the shear connectors were installed by using Sika AnchorFix®-2 + Tropical epoxy resin. Then, after the end of the five-hours curing period, the stirrups were bonded to the anchors. The mechanical and physical properties of the Sika AnchorFix®-2 + Tropical epoxy resin are summarized in Table 10. Then after completing the process of adding shear reinforcement, the beam was cleaned and remolded. A 1 mm layer thickness of the Sikadur®-32 LP was applied to the concrete. Finally, the (SCC) jacket was cast and cured for 28 days by a wet burlap cover.

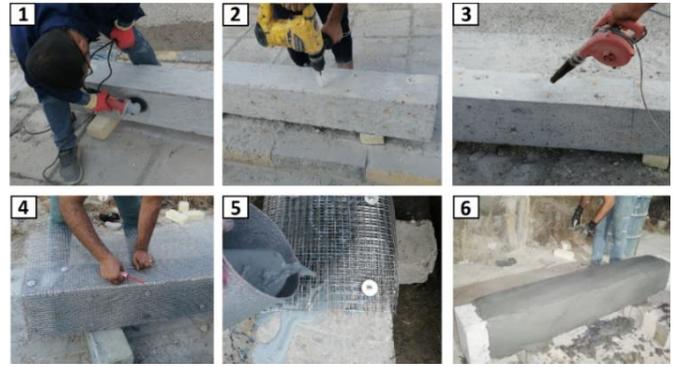
Fig. 6 The steps involved in the strengthening of the beam (S.-J. + Ferrocement).

When the age of the beam becomes 28 days, the sample was prepared for strengthening. The concrete surface was roughened by a grinder, many holes were drilled randomly on the concrete surface, the holes and concrete surface cleaned using compressed air, then the plastic fisher screws were inserted inside the holes (see Fig. 6 (1-3)). The pre-prepared six layers of U wrap steel wire mesh was applied on the three sides of beam faces (the web and the tension zone) and mechanically fixed by using bolts and washers (see Fig. 6 (4)). The pre-prepared bonding bridge liquid was applied to the concrete surface (see Fig. 6 (5)). Finally, the beam was plastered with a 20 mm thick high-quality adhesive mortar and cured for 28 days by a wet burlap cover as shown in Fig. 6 (6).

In this technique, due to the presence of wire mesh, it is not possible to paint the concrete surface with epoxy. Three steps were taken to avoid getting debonding failure and achieve an acceptable connection between the surface of the beam and the ferrocement jacket. The first one was by using mechanical fasteners. The second step was by using a synthetic rubber emulsion (Sika Latex) old-new bonding agent material. The third step was by using high-quality adhesive mortar as a plaster by using the same material. The high-quality adhesive mortar was prepared by using the mix proportion proposed in the datasheet of the Sika Latex. The amount of the mixed materials and the results of its cube compressive strength at age 28 days are presented in Table 12.

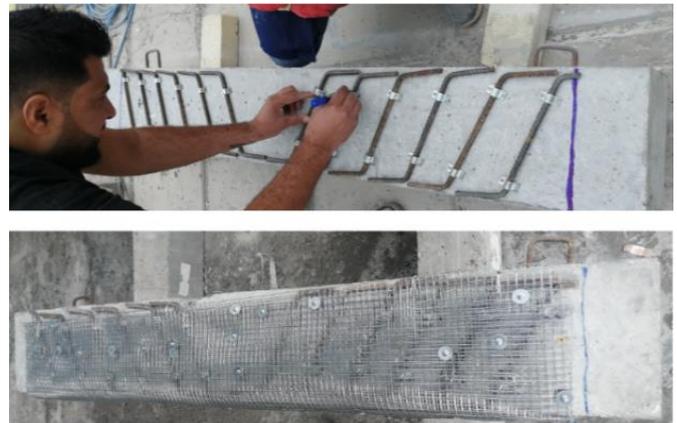
Fig. 7 The configuration of the externally bonded steel rebars used in the strengthening of the beam (S.-J. + Ferrocement + R).

This specimen was strengthened in the same way and the details used in the previous one, with the difference that external steel reinforcing bars were added and mechanically connected on the surface of the beam before the wire mesh wrapping. As shown in Fig. 7 twelve deformed bars of 10 mm (D10) were used on each side of the beam web. The added steel bars were distributed at a distance of 80 mm center to the center and were arranged to be perpendicular on the path connecting the loading point and the beam support.

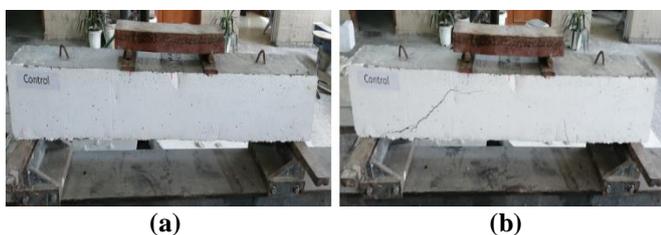
**Fig. 10** The control beam (a) before the test and (b) after the failure.

The control beam displayed a shear failure by forming a major diagonal crack. The first crack appears at a total applied load of 80 kN. The crack was initiated near the support and then propagated to the load application point as the load continues to increase. The complete collapse occurred at a total applied load of 136 kN, and the corresponding ultimate mid-span deflection (Δ_U) was 4.87 mm. Fig. 10 shows the control beam (a) before the test and (b) after the failure.

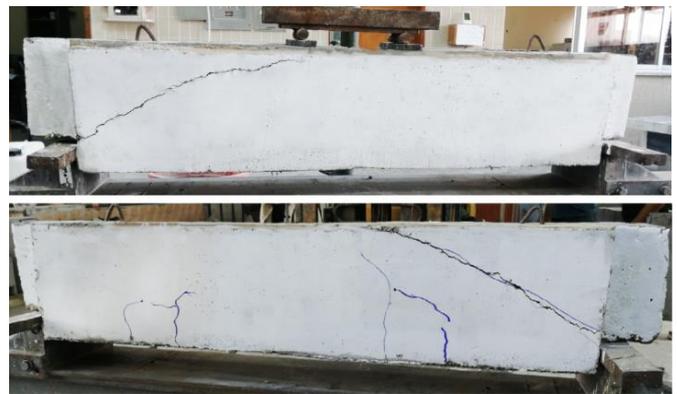
**Fig. 11** The (S.-J. + Steel Fiber) beam after the failure.

As presented in Table 13 the specimen (S.-J. + Steel Fiber) contributed to increasing the load-carrying capacity of the unstrengthen beam by 35 %. The specimen failed due to a significant diagonal crack. The shear crack was initiated under the edge of the loading plate at 94.4 kN applied load, then propagated toward the support point. The beam failed at a 184 kN load with a 5.63 mm corresponding deflection. Fig. 11 shows the two web faces of the (Jac. + Steel Fiber) specimen after failure.

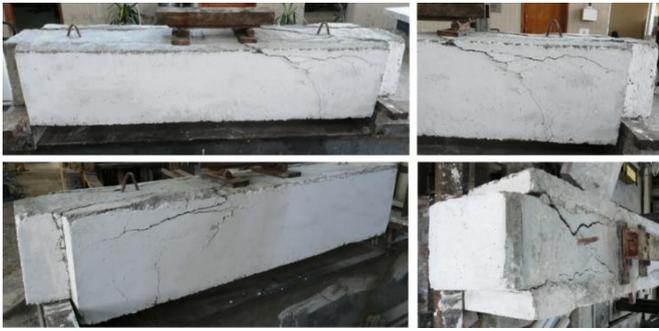
Fig. 12 The (S.-J. + Stirrup) beam after the Testing.

The initial and ultimate failure load of the specimen (Jac. + Stirrup) was 108 kN and 216 kN, respectively. In comparison with the unstrengthen beam, there is a 59 % increase in the load-carrying capacity and a 35 % delay in the initial failure occurrence. The deflection was $\Delta_U = 6.3$ mm at the ultimate load. The beam demonstrates a considerable increase in the shear capacity and the stiffness of the original beam. It was found through the study that the strategy used to strengthen this beam is considered the best approach among all the methods used to enhance the rest of the specimens. Fig. 12 shows the (Jac. + Stirrup) specimen after testing.

The failure mechanism started with the appearance of a vertical crack at the end of the concrete jacket. The crack was initiated on the surface of the original beam and above the edge of the support plate. The crack extended until it arrived at the top surface of the specimen. As shown in Fig. 12, when the applied load approached the ultimate failure load, some cracks appeared on the cover of the concrete jacket. At the final failure load, the beam failed in explosive mode, and widespread cracks appeared on the upper surface of the original specimen.

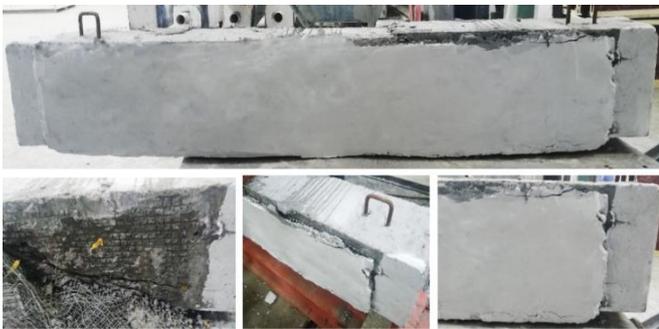
Fig. 13 The (S.-J. + Ferrocement) beam after the failure.

The ferrocement jacket contributed to enhancing the initial and ultimate failure load by 81 % and 30 %, respectively. The technique used in strengthening this beam significantly improved the shear capacity in terms of cracking load. The first shear crack appeared when the applied load reached 82 % of the ultimate failure load. When the applied load became 145 kN a narrow crack appeared near the support plate on the jacket surface. With the increase in applied load, the crack began to expand towards the loading point until the applied load reached the ultimate failure load at 176.3 kN. Debonding of the ferrocement layer occurred at the ultimate failure load, which was accompanied by a sudden shear failure. Fig. 13 shows the specimen S.-J. + Ferrocement after the failure.

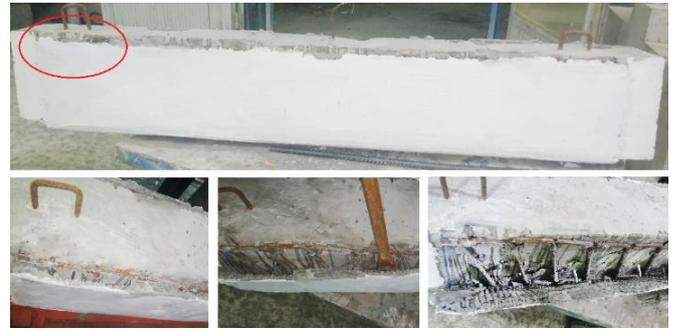
Fig. 14 The (S.-J. + Ferrocement + R) beam after the failure.

Based on the experimental results and as shown in Fig. 9, it was observed that the structural behavior of the beam (S.-J. + Ferrocement + R) was very similar to (S.-J. + Ferrocement) until initial failure load. Compared to the results of the specimen (S.-J. + Ferrocement), the addition of externally bonded steel bars slightly contributed to increasing the rigidity of the strengthened beam. When the applied load has reached 144.2 kN, the beam suddenly failed by debonding the ferrocement jacket, and a large crack was formed connecting the points of support and loading. The shear crack did not appear on the ferrocement jacket but rather was observed after removing the jacketing layer. This type of failure occurred due to the presence of externally bonded steel bars which caused a gap between the surface of the beam and the ferrocement jacket. For this reason, there was a decrease in the adhesive force exist to resist the shear flow. Fig. 14 shows the specimen (S.-J. + Ferrocement + R) after the failure.
