## Evaluation of enamel surface damage after debonding using three different pliers "An in vitro study"

### Abstract

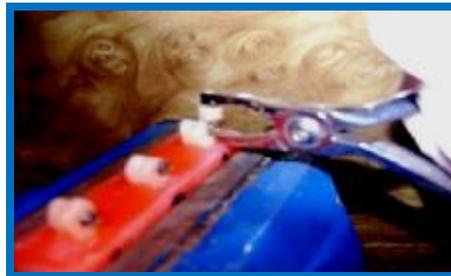
Fig.1: mechanical debonding using conventional debonding pliers.

Group G (st.st & Ce.): Bracket removal with the conventional debonding pliers placed at the base of the bracket, while its beak rests on the tip of enamel surface avoiding unnecessary torque of the tooth (Bennett et al, 1984; Zarrinnia et al, 1995) then the instrument was rotated towards the occlusal edge of the bracket until the bracket was removed<sup>(26)</sup>.

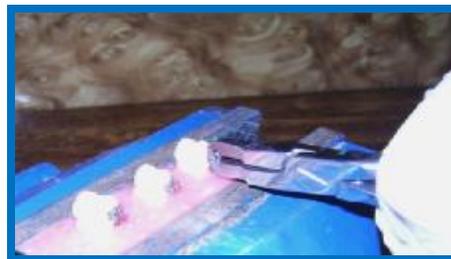
Fig.2: mechanical debonding using bracket removal pliers.

Group R (st.st & Ce.): The tips of the bracket removal pliers were placed under both sets of occlusal and gingival tie-wings and above the base of the bracket. The handles of the instrument were squeezed until the angled ends of the handles met, and the pliers were rotated towards the occlusal edge of the bracket until the bracket was removed<sup>(26)</sup>.

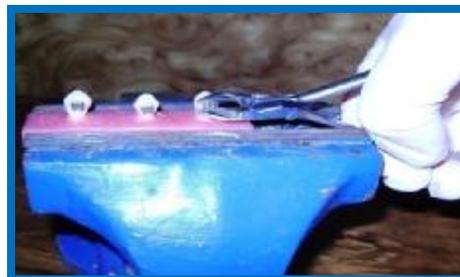
Fig.3: mechanical debonding using ligature wire cutter.

Group B (st.st & Ce.): Bracket removal with the ligature wire cutter that placed at the base of the bracket, and a slight amount of squeezing pressure applied to the handles of cutter until debonding occurred<sup>(2)</sup>.
